**SAMPLE REPORT 1**

**LEVEL 2 HOME SURVEY**

Mid-terrace property

Built 1900-1910

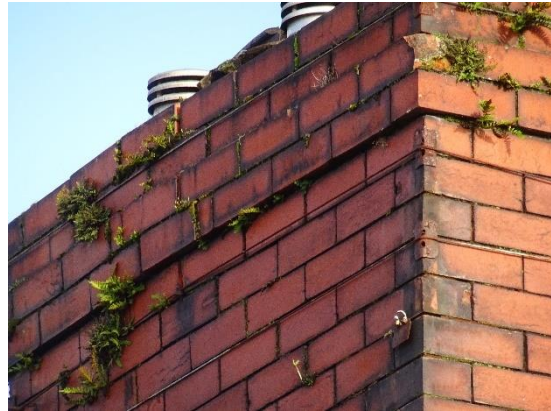
- Lichen and moss was noted to the head of the main stack. This should be cleared to prevent deterioration of the cement. It may be necessary to repoint the stack masonry once moss has been cleared & you should therefore budget for this potential additional cost.

Main chimney stack – lichen/moss

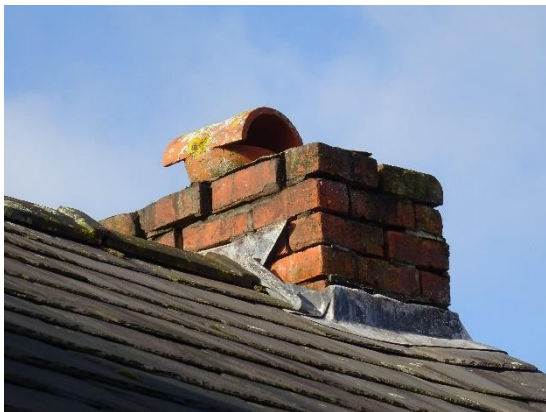
- The flashings to the annex stack are loose & pulling away in places. Repairs are required to reduce the risk of future defects developing.
- Bearing in mind the annex stack is not being used, and the risk of future problems arising, it may be more economical to consider taking it down beneath the roof covering. While costly this would prevent the on-going maintenance liability. Permission may be required and you should check with the Local Authority Planning Department before undertaking any such work. In the meantime regular inspections should be carried out to check for signs of further deterioration.

Rear annex stack – loose flashings

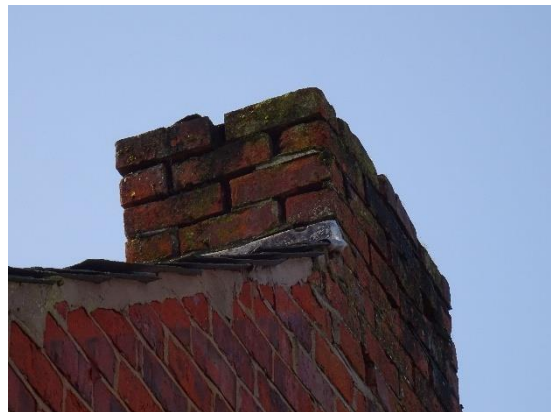
- The mortar pointing to the annex stack has perished in places. Re-pointing of the affected areas is required to reduce the risk of future defects developing.

Rear annex stack – perished pointing

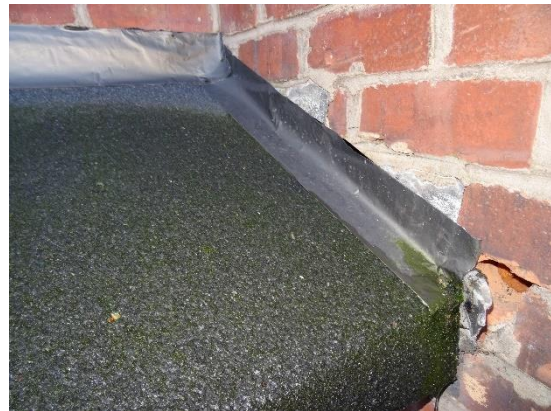
- The bay roof is leaking as evidenced by damp staining to the underside of the roof in the rear living room. It is thought this is caused by leakage past the temporary self-adhesive flashings which are of poor quality and designed for patching purposes only. The flashings should be replaced with a more durable material such as lead to reduce the risk of future defects developing.

Rear bay roof – leaking flashings

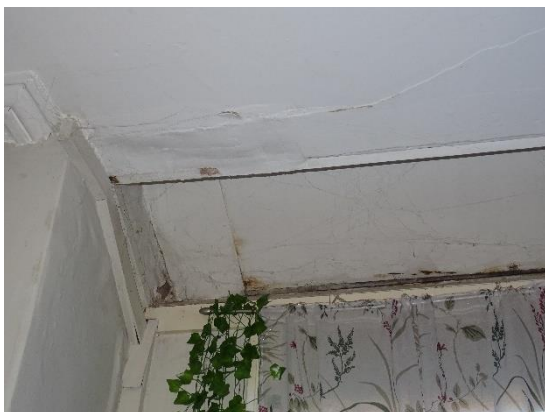
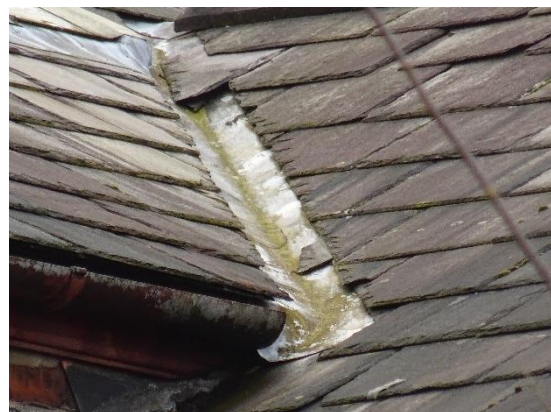
Rear bay roof – leakage internally

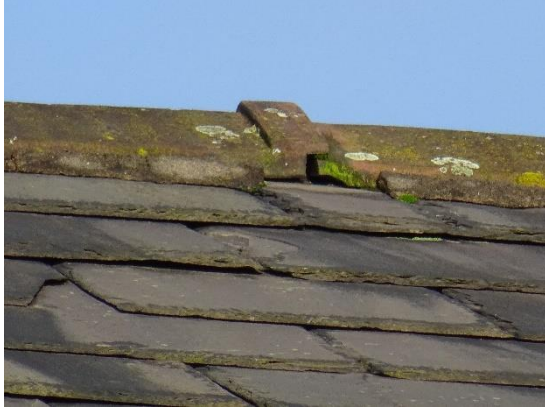
- Some of the slates to the main roof valley gutter are loose/have slipped. Repairs are required to prevent water ingress by a reputable roofing contractor.
- Some of the mortar pointing to the ridge tiles is missing, cracked and starting to loosen. Re-pointing is required to reduce further deterioration and water ingress.
- Valley gutters are vulnerable locations for damp penetration. As part of the repairs outlined above, a closer inspection of the valley lead should be undertaken in order to determine its condition and possible need for replacement.

Main roof ridge tiles – repairs required

Rear valley gutter/annex roof – slipped slates

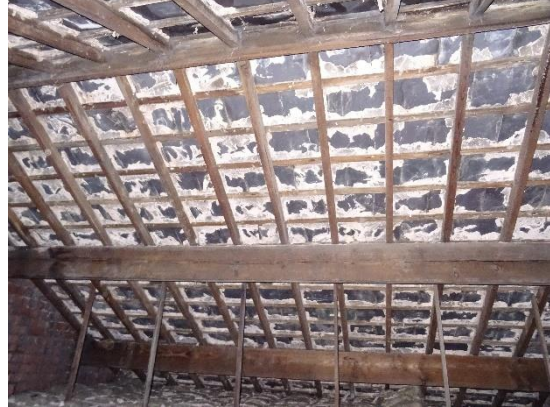
Original main roof covering – no underlining

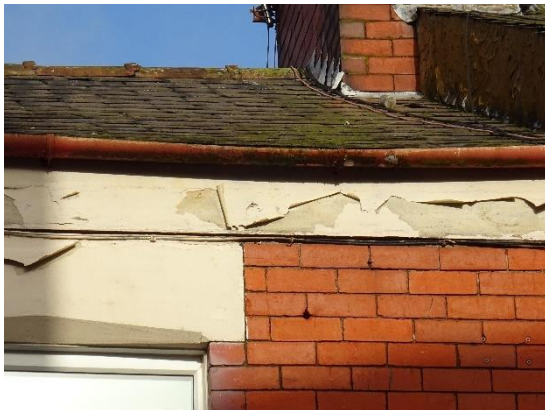
- The guttering to the front elevation is sagging/misaligned and the joints are leaking. The guttering should be replaced to reduce the risk of future defects developing.

Guttering to front elevation – sagging

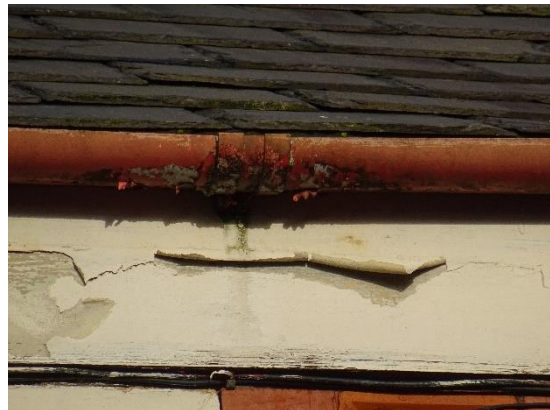
Guttering to front elevation – leaking joints

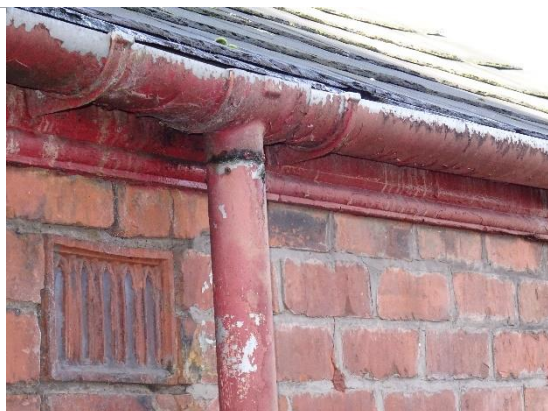
- Some of the downpipe joints are stained and possibly leaking. These should be repaired / sealed to reduce the risk of future defects developing.

Leaking rainwater pipe joints

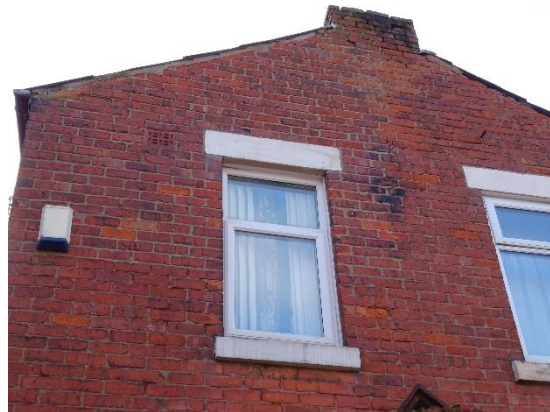
- There is evidence of lateral movement in the form of bulging masonry to the annex gable elevation at high level which is indicative of wall-tie failure.

Cavity brick walls are formed in two leaves which are usually held together with metal wall ties. Walls that were constructed prior to 1980 are prone to wall tie failure but without an endoscopic inspection of the wall ties it is not possible to say what kind of condition the wall ties are in. Wall tie failure can cause serious damage to buildings although repairs can be implemented if the issue is seen early enough (remedial wall-ties). Wall tie corrosion usually causes horizontal cracking across the mortar joints in the initial stages and bulging masonry in later stages.

Annex gable elevation – bulging masonry

To avoid any progressive issues which could cause further damage, you should now obtain a report from a specialist contractor such as a member of the Property Care Association on the condition of the wall-ties in order to establish the extent of the necessary remedial work required.

You should not proceed with your purchase until you have obtained this report and established liability for any costs necessary. If wall-tie failure is confirmed, remedial works could include the rebuilding of part of/or all of the affected elevation which will be costly. It may be possible the affected wall could be retained, however, by the installation of remedial cavity wall-ties.

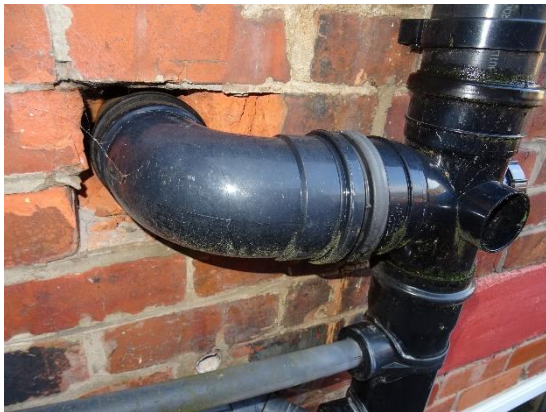
- The mortar pointing is perished to the lower annex gable elevation. Localised re-pointing is required to reduce the risk of future defects developing.
- There are gaps in the masonry around some service pipe penetrations to the rear annex. Localised filling & re-pointing is required to reduce the risk of water penetration.

Holes/gaps around pipe penetrations

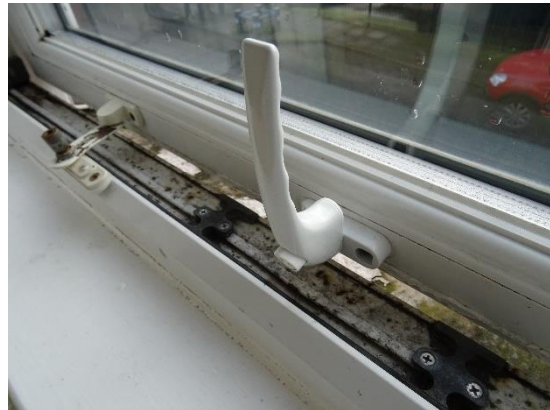
Loose/worn handles

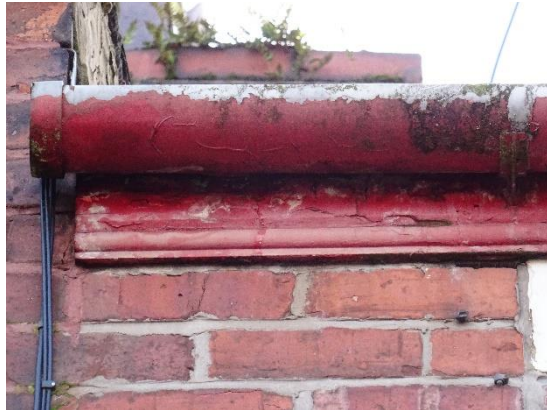
Weathered decorations

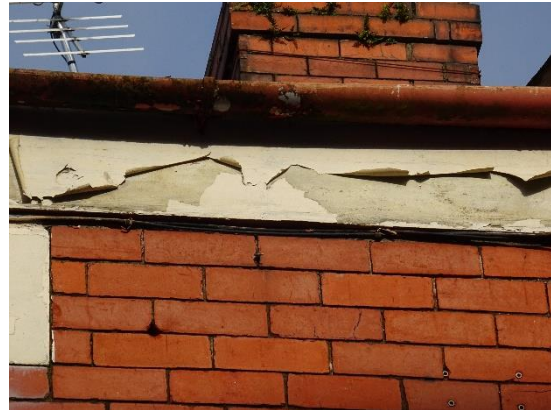
Weathered decorations

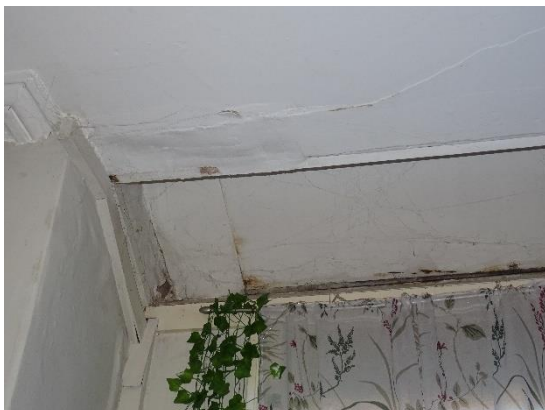
Damaged ceiling due to water ingress – rear living room

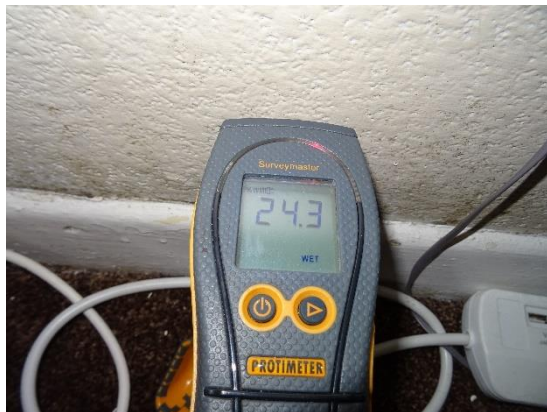
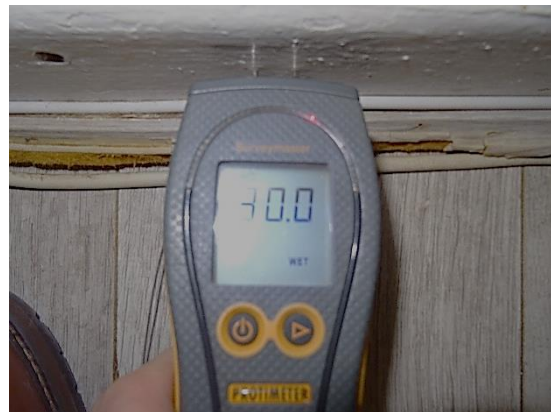
The pattern of damp within the walls would indicate the most likely cause of the damp to be a combination of factors including rising dampness from the ground, deterioration or failure of the damp-proof-course & the deteriorating external wall surfaces.

High moisture meter readings

In the event further remedial works are not covered under warranty, further specialist investigation is needed by a member of the Property Care Association in order to fully establish the extent of damp within the property and confirm its precise cause so that a remedial treatment plan can be advised. As a precaution, the whole property should be inspected.

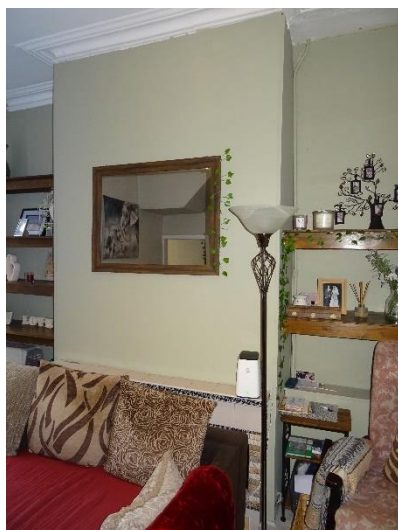
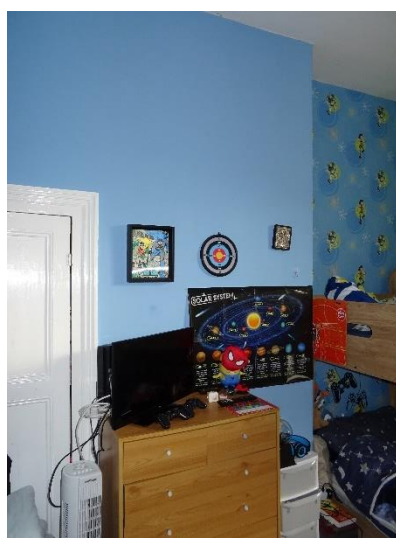
No ventilation to redundant fireplace / flue

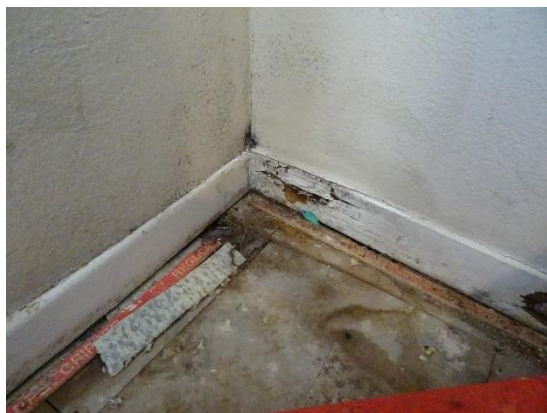
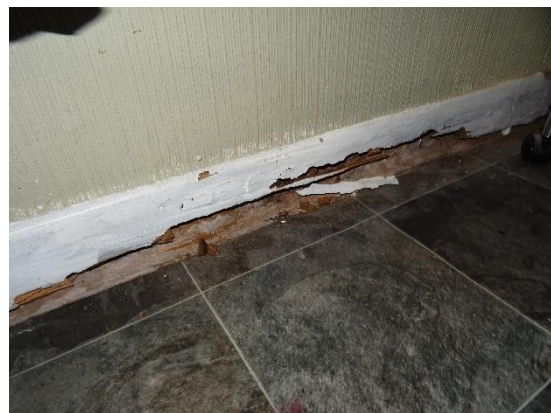
Timber decay

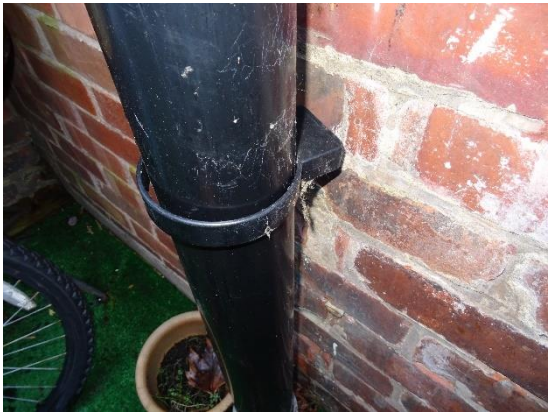
Loose soil pipe – broken clip

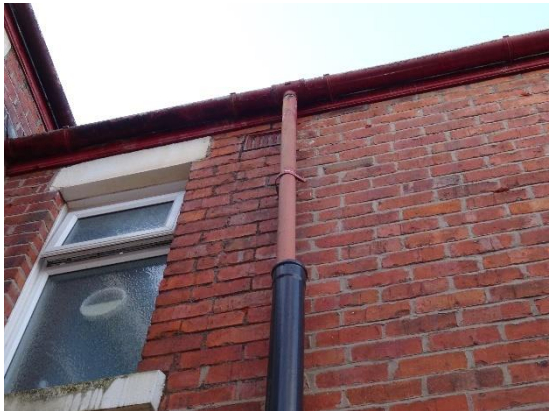
Rainwater pipe connected to soil pipe

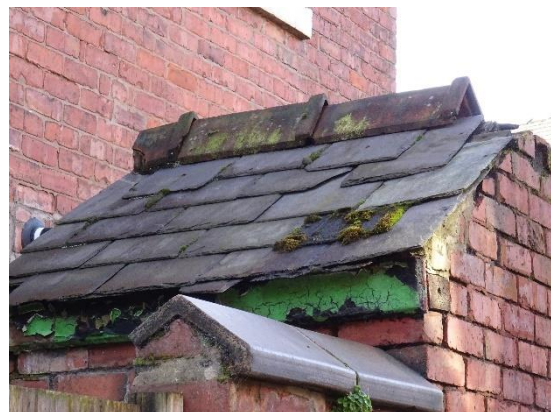
Slate repairs required

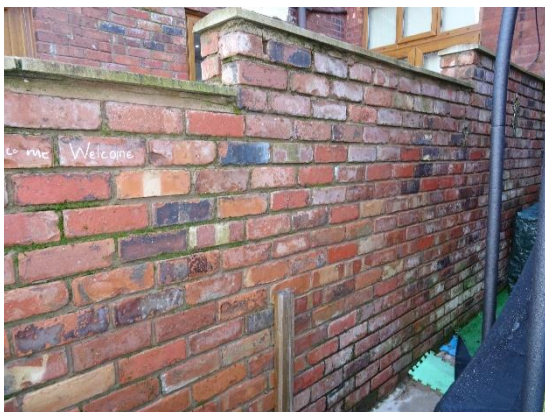
Loose concrete copings to yard wall
