**SAMPLE REPORT 1**

**LEVEL 2 HOME SURVEY**

Mid-terrace property

Built 1900-1910

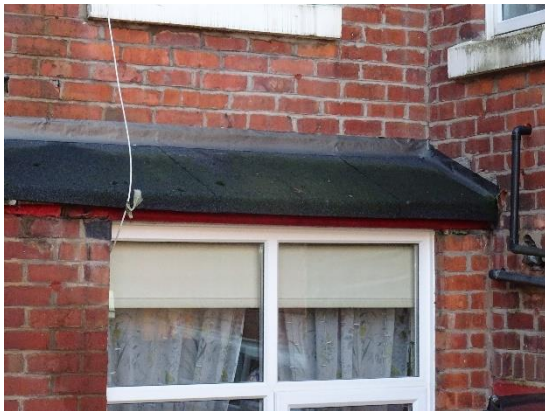
Rear felt bay roof

- The bay roof is leaking as evidenced by damp staining to the underside of the roof in the rear living room. It is thought this is caused by leakage past the temporary self-adhesive flashings which are of poor quality and designed for patching purposes only. The flashings should be replaced with a more durable material such as lead to reduce the risk of future defects developing.

#### **Condition Rating 3.**

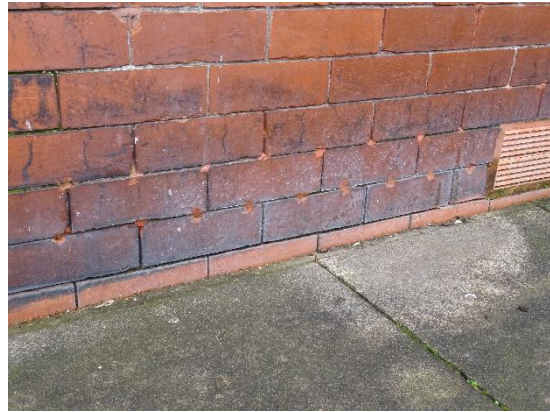
Remedial injected damp proof course

The pattern of damp within the walls would indicate the most likely cause of the damp to be a combination of factors including rising dampness from the ground, deterioration or failure of the damp-proof-course & the deteriorating external wall surfaces.

### Condition Rating 3.

In the event further remedial works are not covered under warranty, further specialist investigation is needed by a member of the Property Care Association in order to fully establish the extent of damp within the property and confirm its precise cause so that a remedial treatment plan can be advised. As a precaution, the whole property should be inspected.

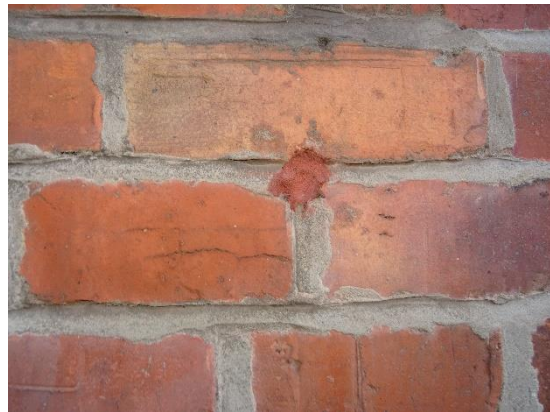
Evidence of cavity wall insulation

Inadequately installed cavity wall insulation can cause moisture to penetrate the internal leaf of a cavity wall, causing structural problems and damp patches that may also manifest into mould. No such issues were noted during the inspection however this is a possibility in the future.

Older cavity wall insulation treatments often used a formaldehyde foam which, in time, can degrade and allow damp to penetrate through the wall thickness. It can also result in accelerated corrosion of cavity wall ties. Your legal advisers should be asked to verify the type of insulation used and the existence of any guarantees.

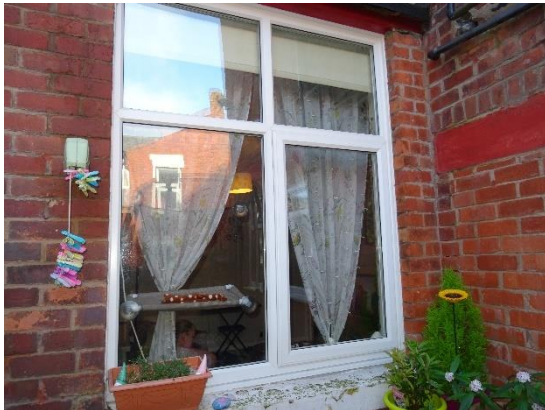
Upvc windows

In other respects, the windows are slightly worn and weathered but in reasonable condition allowing for age. The sealant to the frame surrounds also appeared free from any significant deterioration. Checks were made for internal damp ingress to the window sills and frame reveals and no damp was found. It is essential that the seals between the window frames and the walls are regularly checked and kept in good condition to reduce the risk of water ingress and damp.

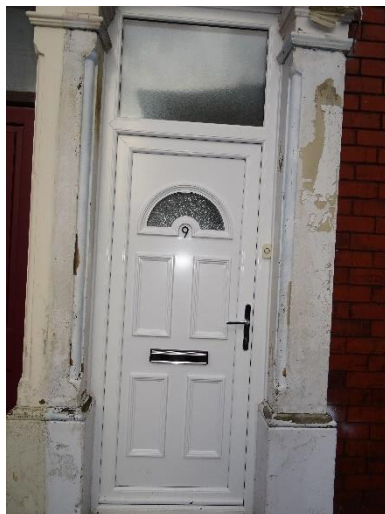
Front door

- The doors were checked for operation and were found to be generally in a serviceable condition although some wear and tear is evidence to the door furniture from use. The sealant to the frame surrounds also appeared free from any significant deterioration. There were no signs of condensation between double glazed panes at the time of inspection.

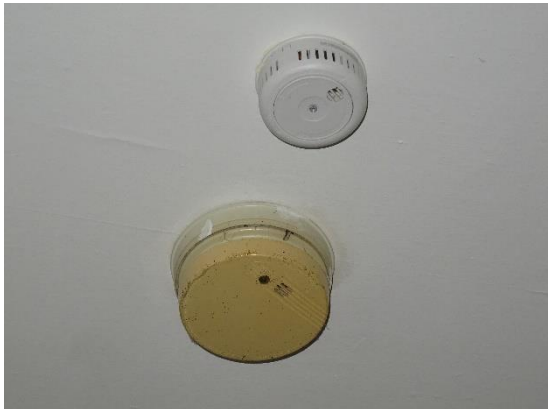
Smoke alarms

These matters are a risk to the occupants and a safety hazard. You should obtain advice from a fire officer or an appropriately qualified specialist on all necessary improvements and precautions that can be undertaken to mitigate risks.

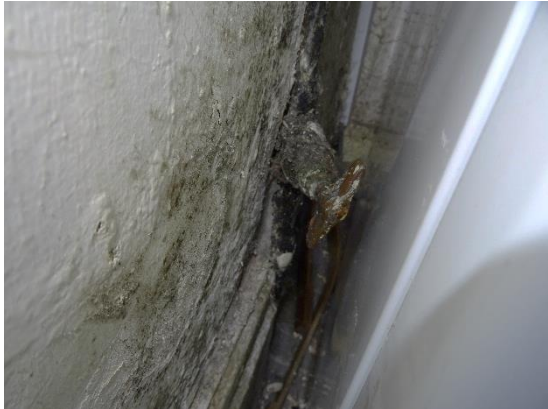
Internal stop tap

Elsewhere, most of the internal distribution pipework is concealed within the structure or behind fittings and whilst there were no obvious signs of significant leaks, the possibility of concealed defects exists.

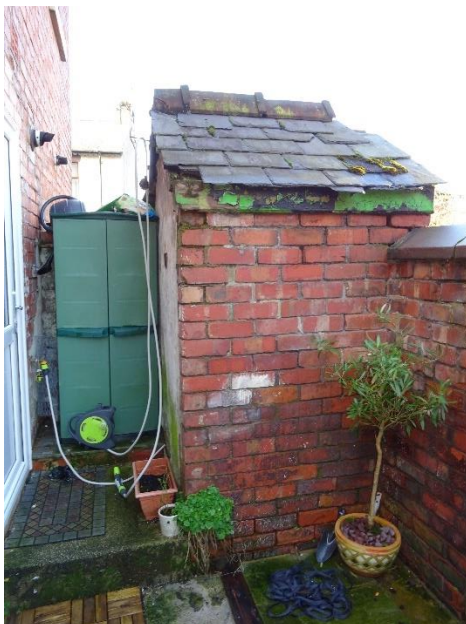
Outbuilding

In other respects the outbuilding is in satisfactory condition but there is evidence of normal weathering.

I understand it is your intention to demolish and remove the outbuilding to enable the kitchen to be extended outwards into the yard area. In the first instance and before formal plans are drawn-up for statutory approval, your Legal Adviser should make appropriate enquiries to determine whether the outbuilding is in shared ownership with the adjoining property or it is in sole ownership of the subject property.

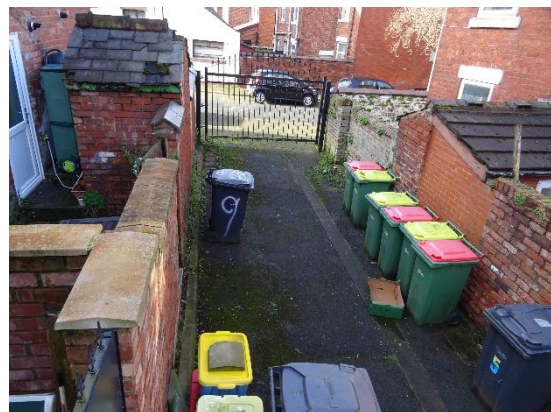
Rear alleyway with alley gates

There are lockable alley gates to the rear alleyway to the rear of the property/terrace. This would suggest that the property enjoys access to this for maintenance and/or alternative access to the rear yard. You should ask your Legal Adviser to make appropriate enquiries about your rights and responsibilities regarding the alley gates & alleyway and any right-of-way that may exist.
